OPERATING EXPERIENCE SUMMARY

U.S. Department of Energy
Office of Health, Safety and Security
OE Summary 2007-09
December 28, 2007

Near Miss — Shelving Units Collapse

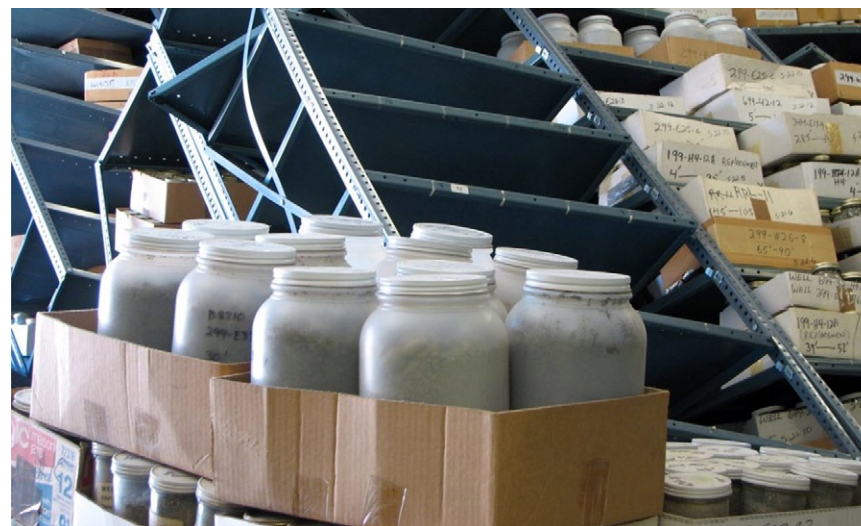
The storekeeper was relocating boxes of soil samples from a pallet to the free-standing shelving where they were stored. As he was pushing a box from the front of a shelf to the rear of it, the bottom part of the shelf wall gave way, and the entire unit began to collapse and fall. Figure 1-1 shows the box of soil samples that the storekeeper was shelving, as well as the fallen shelving units. Figure 1-2 shows the aftermath of the collapse and the fallen second unit. Had the shelving fallen in the opposite direction, the storekeeper could have been badly injured.

Investigators determined that when the shelves were assembled the manufacturer's instructions were not followed. They also determined that the shelves were poorly braced. In addition, the fasteners used to connect individual sections of shelving were not checked after assembly to ensure that all of them were installed and had been properly tightened.

Figure 1-1. Box of soil samples and collapsed shelves

units. More manual labor would have been required to load the heavy soil samples on the shelves without the fork truck, so the decision was made to install the cross-bracing after the shelves were loaded. Because neither the bottom nor top tier of shelves was cross-braced, the shelving was vulnerable to failure when it was carrying a normal vertical load.

1. Always obtain and use manufacturer's assembly instructions.
2. Never make modifications which may degrade structural integrity without an engineering analysis and approval.
3. Inspect and verify that free-standing shelving fasteners used to connect sections are present and tightened; ensure adequate cross-bracing is present in each section and that it is adequate for the loads they contain and is attached to the facility structure in some fashion (bolted to the floor, fastened directly to the wall, or uses a grid system of bracing to fasten one section to another).

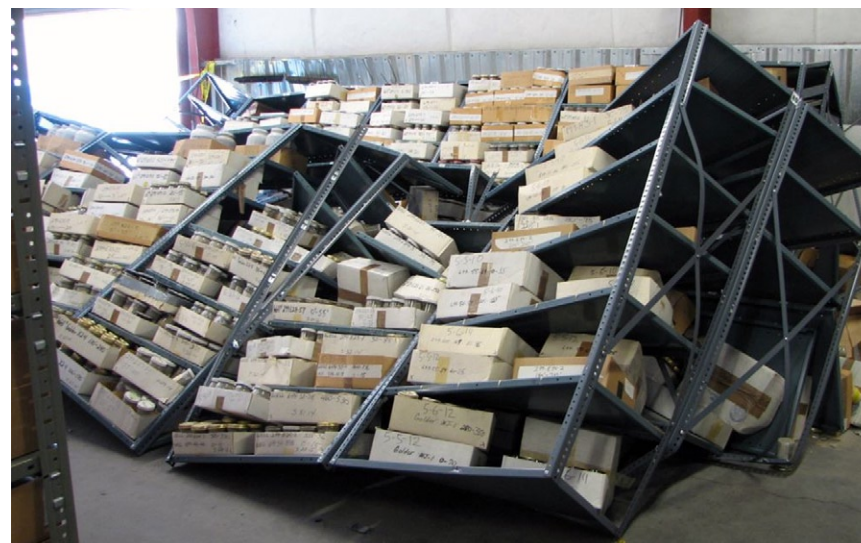
Figure 1-2. Aftermath of shelving collapse

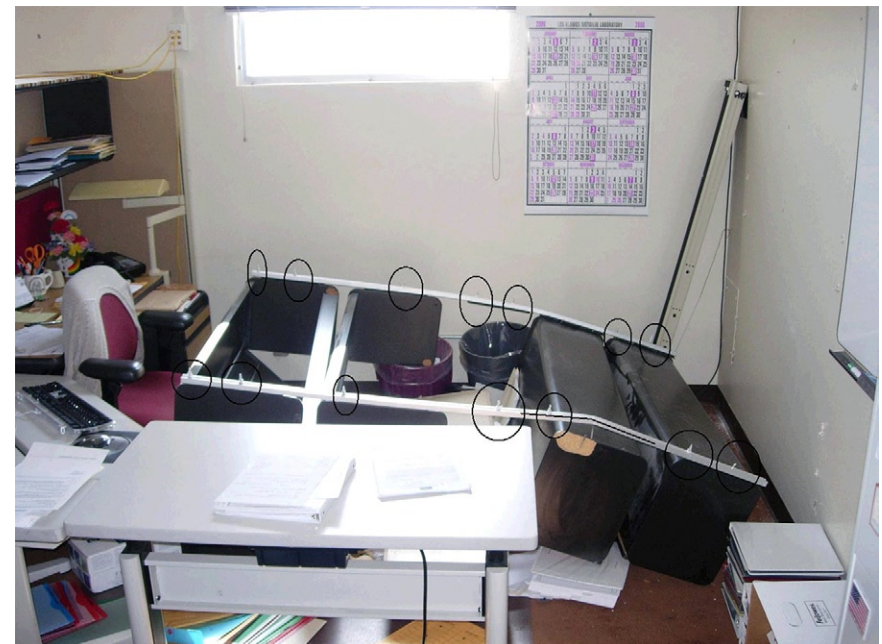
On June 29, 2006, at the Nevada Test Site (NTS), wall-mounted cabinets in an office fell to the floor. The shelving had been mounted to drywall with self-drilling drywall anchors and weighed about 250 to 350 pounds. No one was in the room when the shelving fell, but as can be seen in Figure 1-3, the employee who worked in the office could have been injured, perhaps seriously. (ORPS Report NA--NVSO-BOPNV-2006-0001)

the cabinets be removed so that rail attachments to the wall could be strengthened; however, the shelving fell before repairs could be made. Investigators determined that only 7 of the 12 manufacturer-required anchors had been installed. When several anchors pulled through the drywall, the remaining anchors could not support the weight of the cabinet and shelves. A Lessons Learned Bulletin (2006-LANL-NTS-001) on the event states that “not following manufacturer's instructions for wall-mounted cabinets can result in catastrophic failure.”

Figure 1-3. Fallen office shelving (anchors are circled)
